The
San Francisco Earthquake and Fire

A BRIEF HISTORY OF THE DISASTER

A Presentation of Facts and Resulting Phenomena, with Special
Reference to the Efficiency of Building Materials
Lessons of the Disaster

A. L. A. HIMMELWRIGHT, C.E.

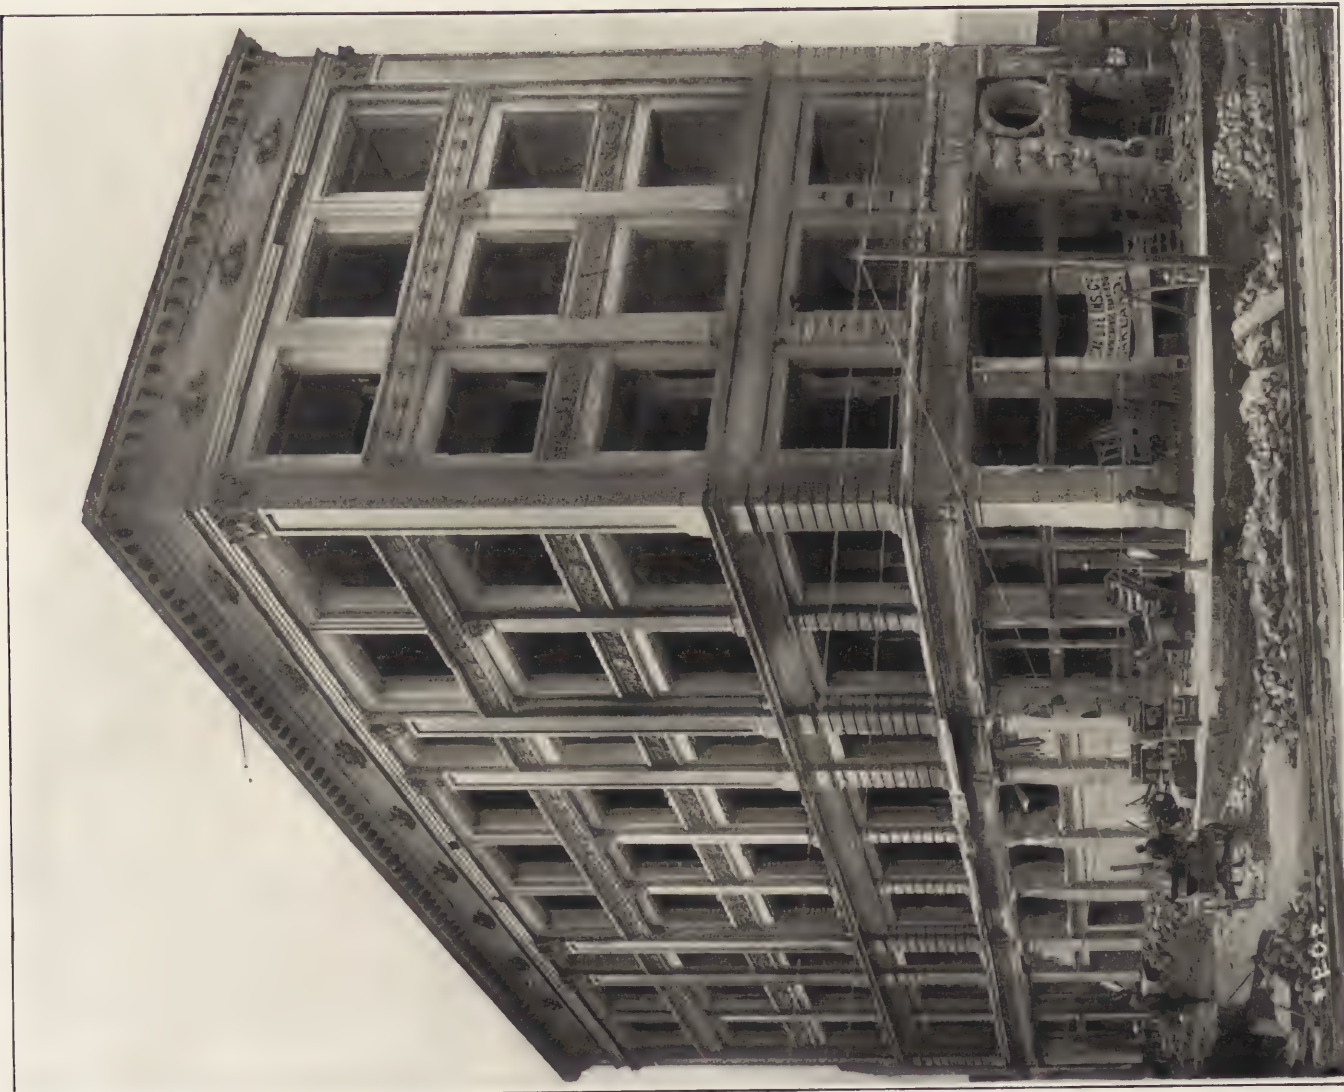
YOUNG (OR SELLER) BUILDING. Southwest Corner Spear and Market Streets. The granite of the first story is very badly spalled, and will require complete renewal. The terra cotta brick and terra cotta ornamentation above is much less injured, but is spalled and cracked in many places. The foundation on the east side has settled, and the east and west walls are out of plumb about 5". The columns were protected by expanded metal lath and plaster and remain in good condition. The steel beams and girders of the second floor are protected on the underside by a flat ceiling of expanded metal lath and plaster, and are in good condition. In the upper stories, where the soffits are exposed, the steel framing is badly deflected. The concrete floors are of the expanded metal suspender type of cinder concrete, and are in fair condition in the two lower tiers, but in the upper tiers the floor construction is badly sagged on account of the suspender bands being unprotected. The hollow tile partitions inclosing the stairway in the first story and the toilet room in the second story are down. The hollow tile wall furring is badly damaged, and is off in many places. Note the good condition of the soffits of the window openings, which were protected by terra cotta anchored into place by $\frac{1}{4}$ " round steel rods.

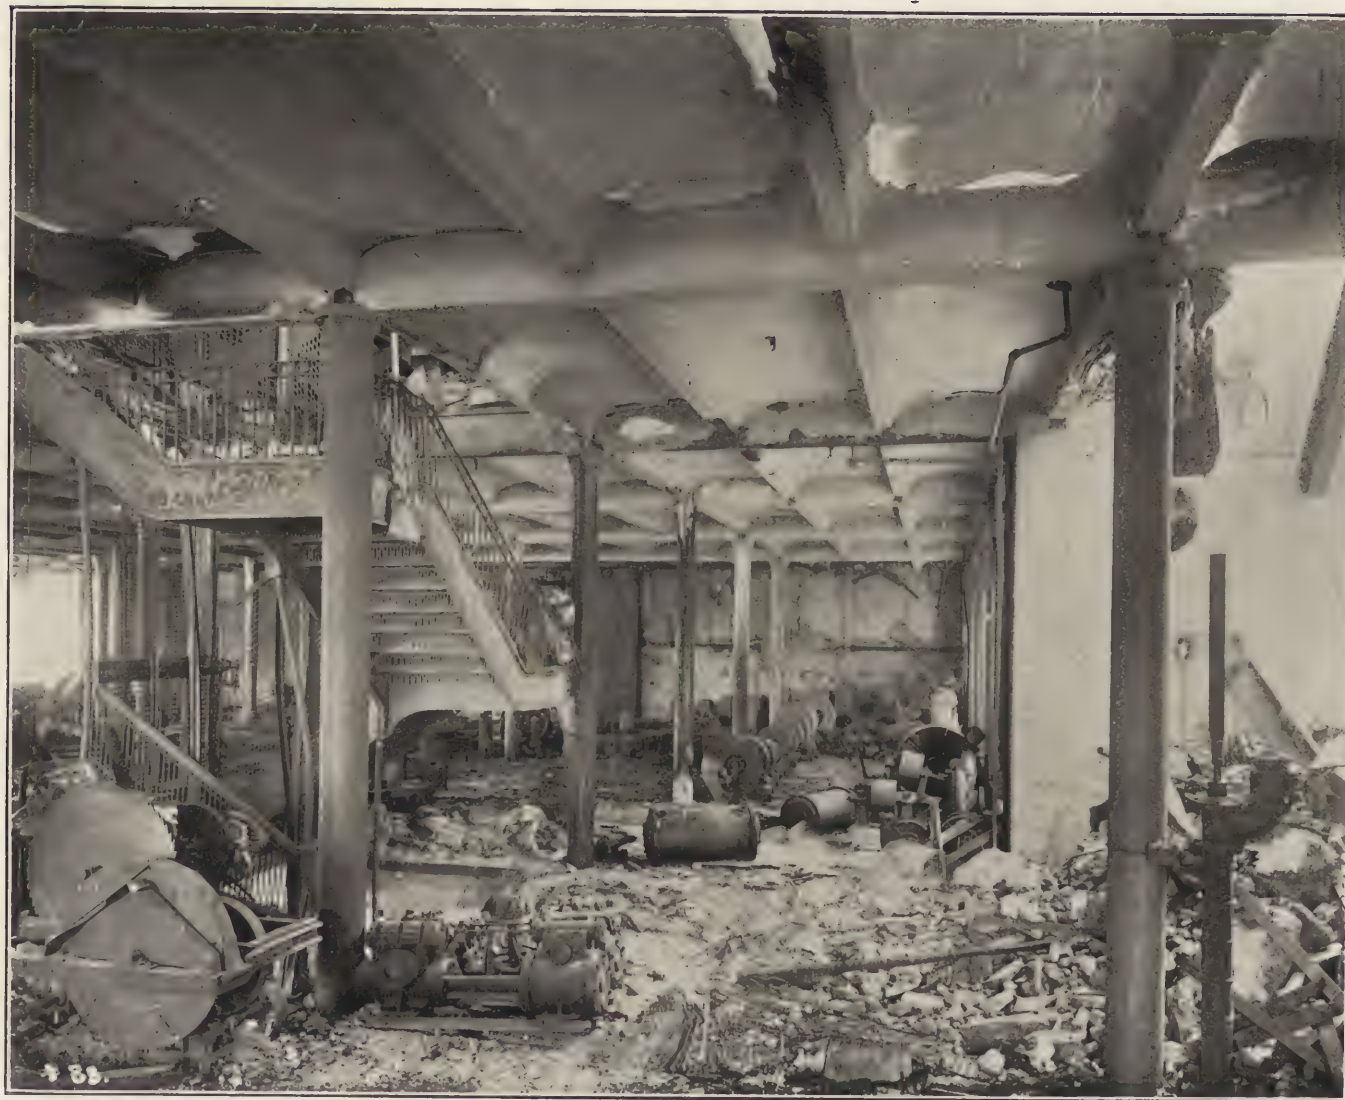
SCOTT BUILDING. Second Story. Typical view showing the condition of the expanded metal concrete floors and the soffit protection of the girders and beams. The stairway well was not enclosed and the cast-iron columns were unprotected.

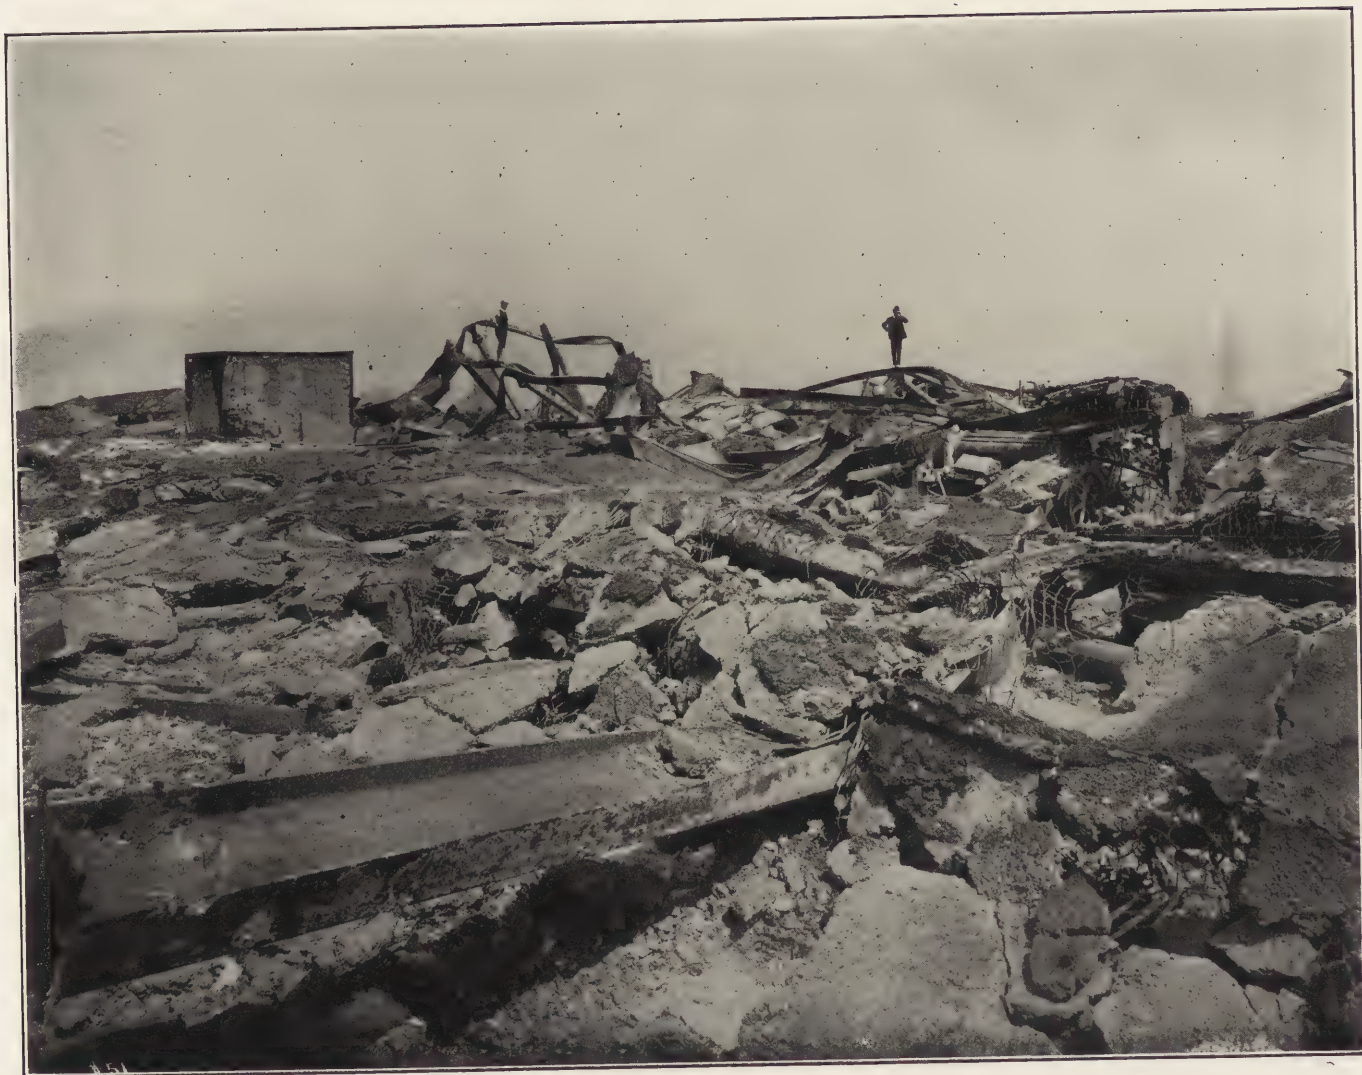
SCOTT BUILDING. Showing the ruins of the roof. The columns supporting the roof were of light section, and unprotected. The burning of the stock and furniture of a printing establishment, occupying the story directly under the roof, heated the columns sufficiently to cause their failure, the entire roof falling to the floor below and breaking the roof concrete into small fragments.

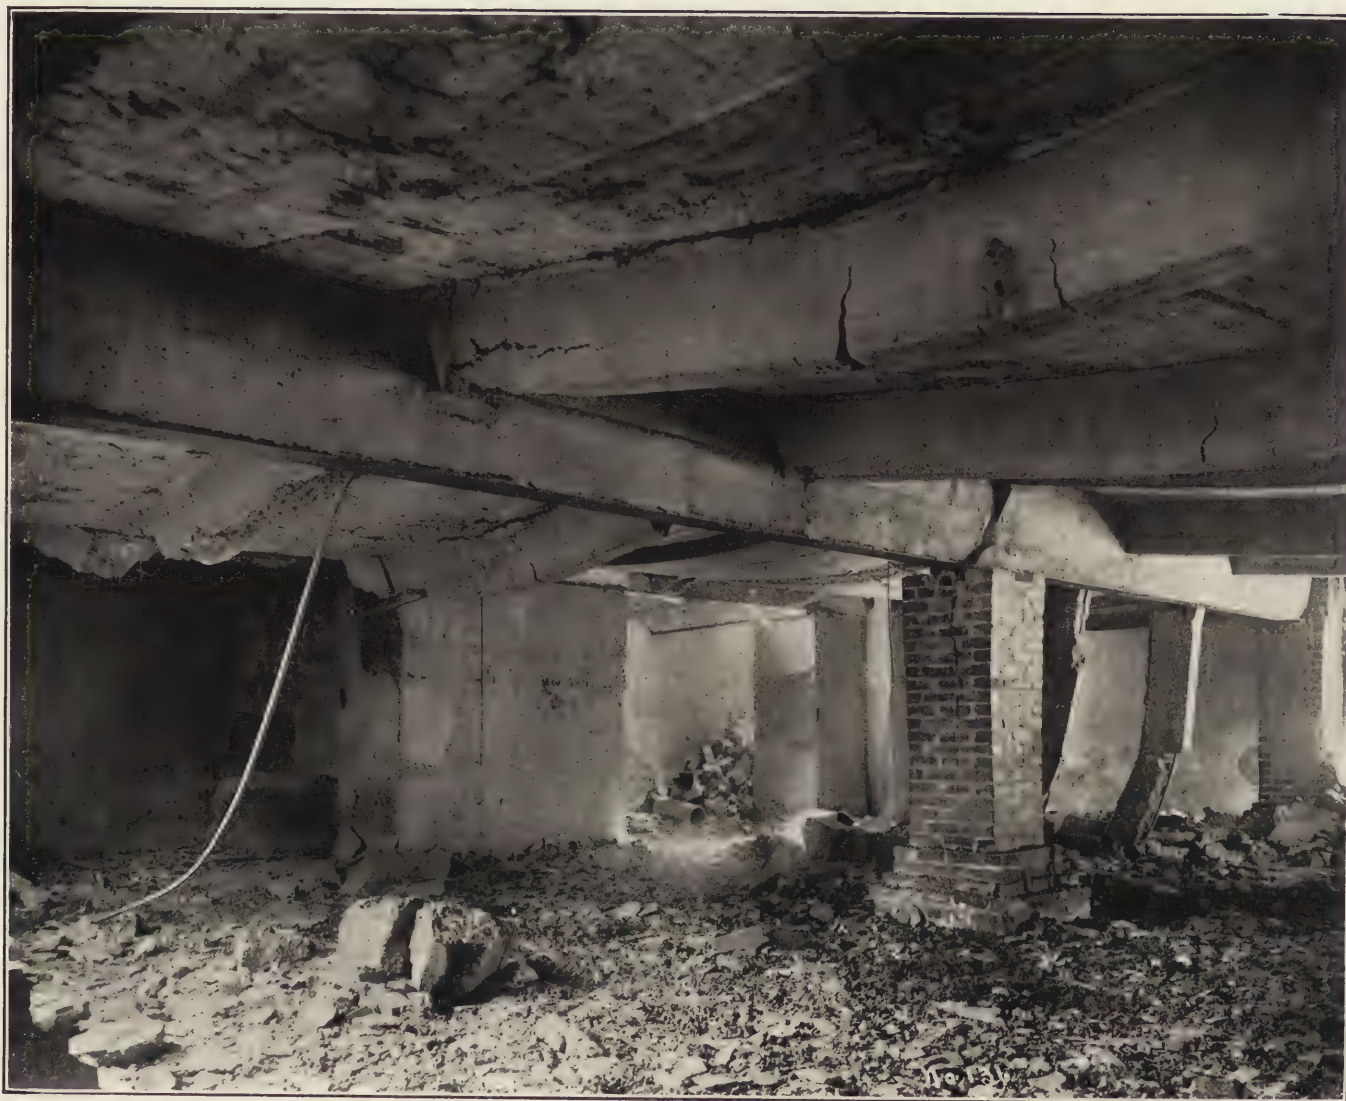
JOHNSON & COMPANY'S BUILDING. Basement Story. Showing the failure of the reinforced concrete beams. There was no load resting on the section of the concrete floors shown. A hot fire in the basement, which contained the hardware stock of a harness and leather concern, caused the damage. The floor slab with reinforced concrete beams, where the latter did not fail completely, deflected as much as 12 inches between the girders in some places. The two reinforced concrete beams, which failed in the rear, are hanging down at the right-hand side. The floor slab is still in position, but has sagged about 18 inches at the centre of the span. Note the sections of the reinforced concrete beams that failed, at the left, still clinging to the floor slab. From a position a little to the left of where the photograph was taken, the rods of the nearest reinforced concrete beams can be seen crossing the cracks in the concrete.

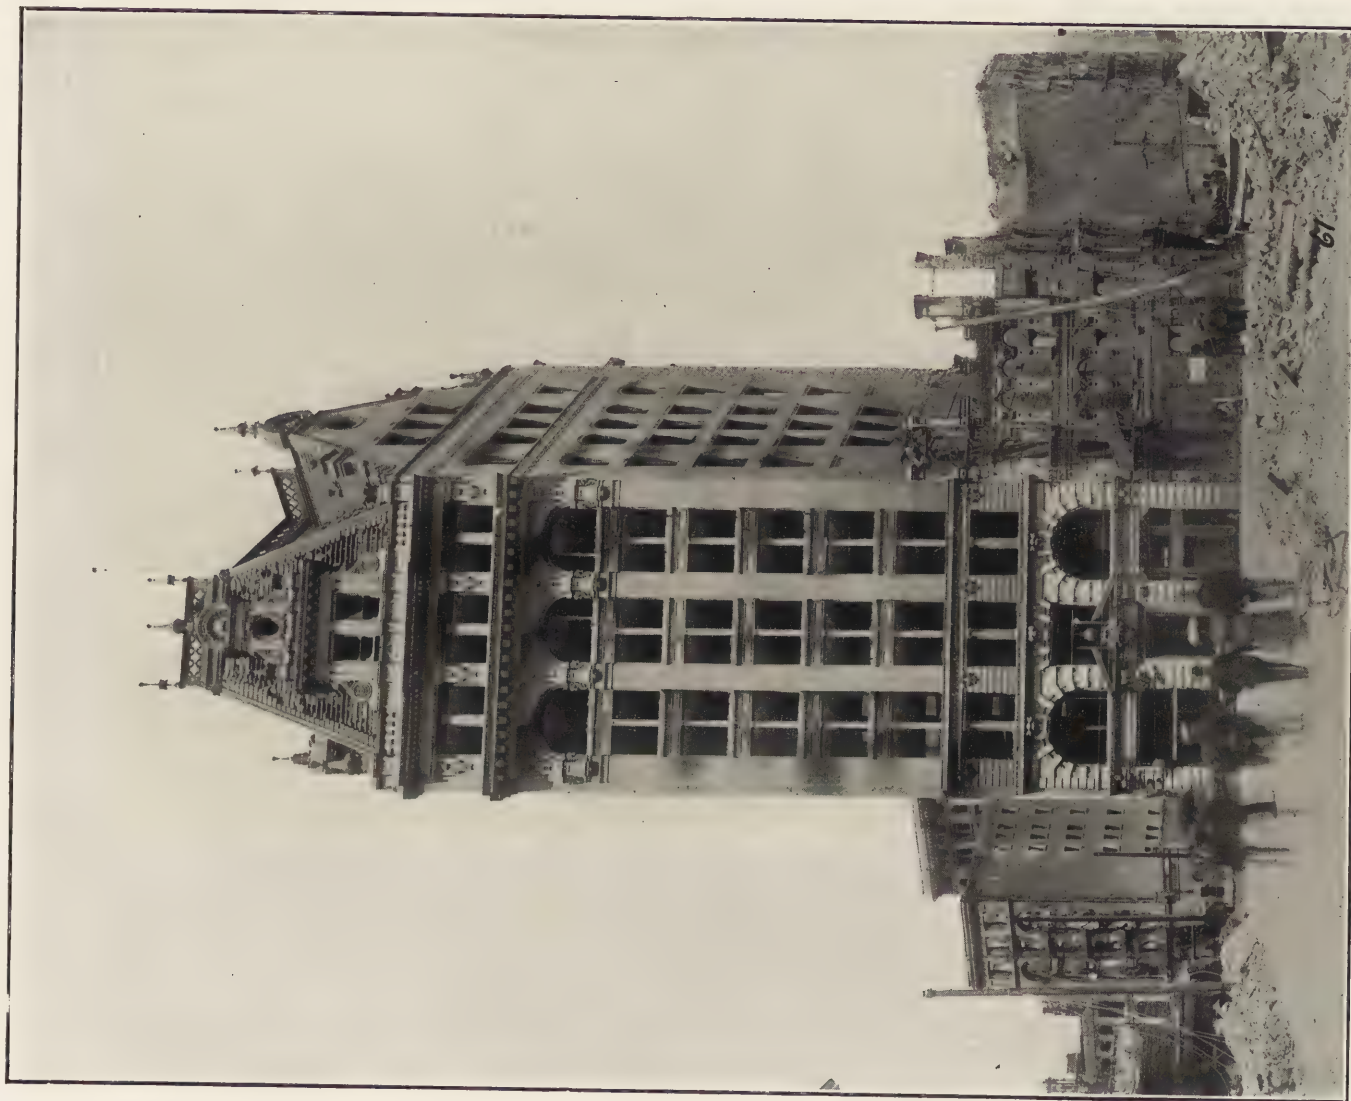
MUTUAL SAVINGS BANK. Junction of Market, Geary and Kearny Streets. The façades consist of Raymond gray granite for the first story and Colusa sand stone above. This building is structurally uninjured. The foundations are level and the walls remain plumb. The greatest damage sustained by the exterior was on the Geary Street side, which must be wholly renewed, and the tile roof, large portions of which must be rebuilt. The other fronts of the building are but slightly damaged. The Roebling concrete floors and wire-lath ceilings throughout are uninjured. The column protection consisting of a double thickness of Roebling wire lath and plaster, with an air space between, is in first-class condition. All the wire-lath and plaster partitions remain standing, although deflected and buckled out of line in some places.

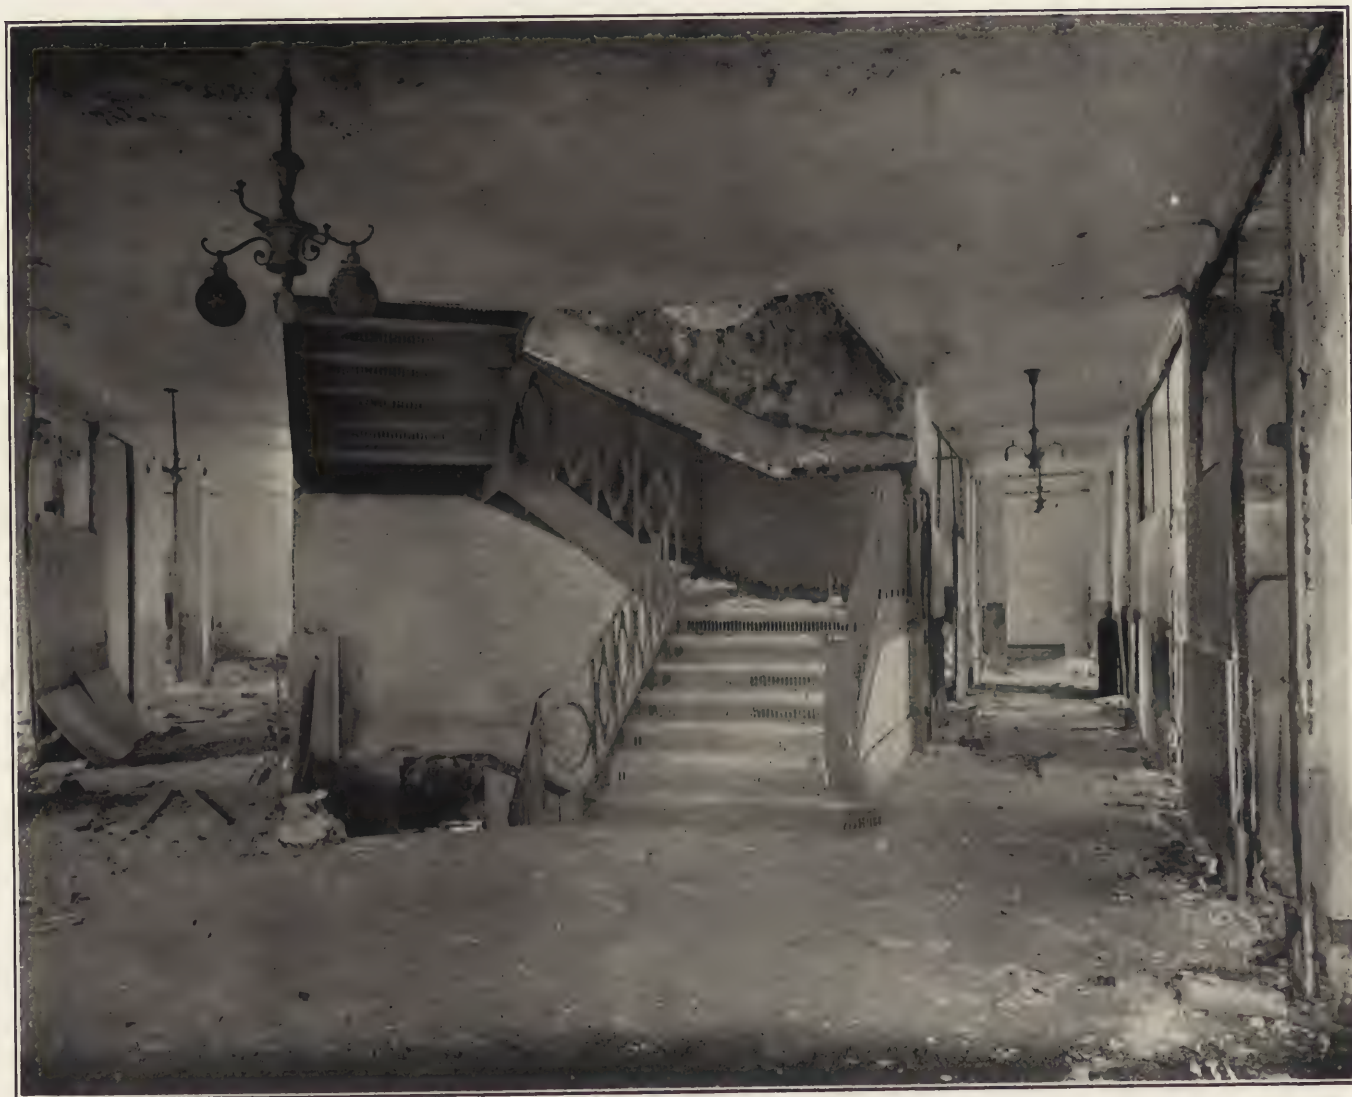
MUTUAL SAVINGS BANK. Typical view showing the condition of the Roebling concrete floors and the Roebling wire lath and plaster partitions and ceilings. Leaning against the left-hand rail of the stairway is a pile of melted zinc, which was originally a copper-plated newel post. At the extreme left are two slabs of warped marble wainscoting. Note the absence of *débris* on the stairway and in the hallways. The *débris* is limited almost exclusively to a portion of the plaster finish.

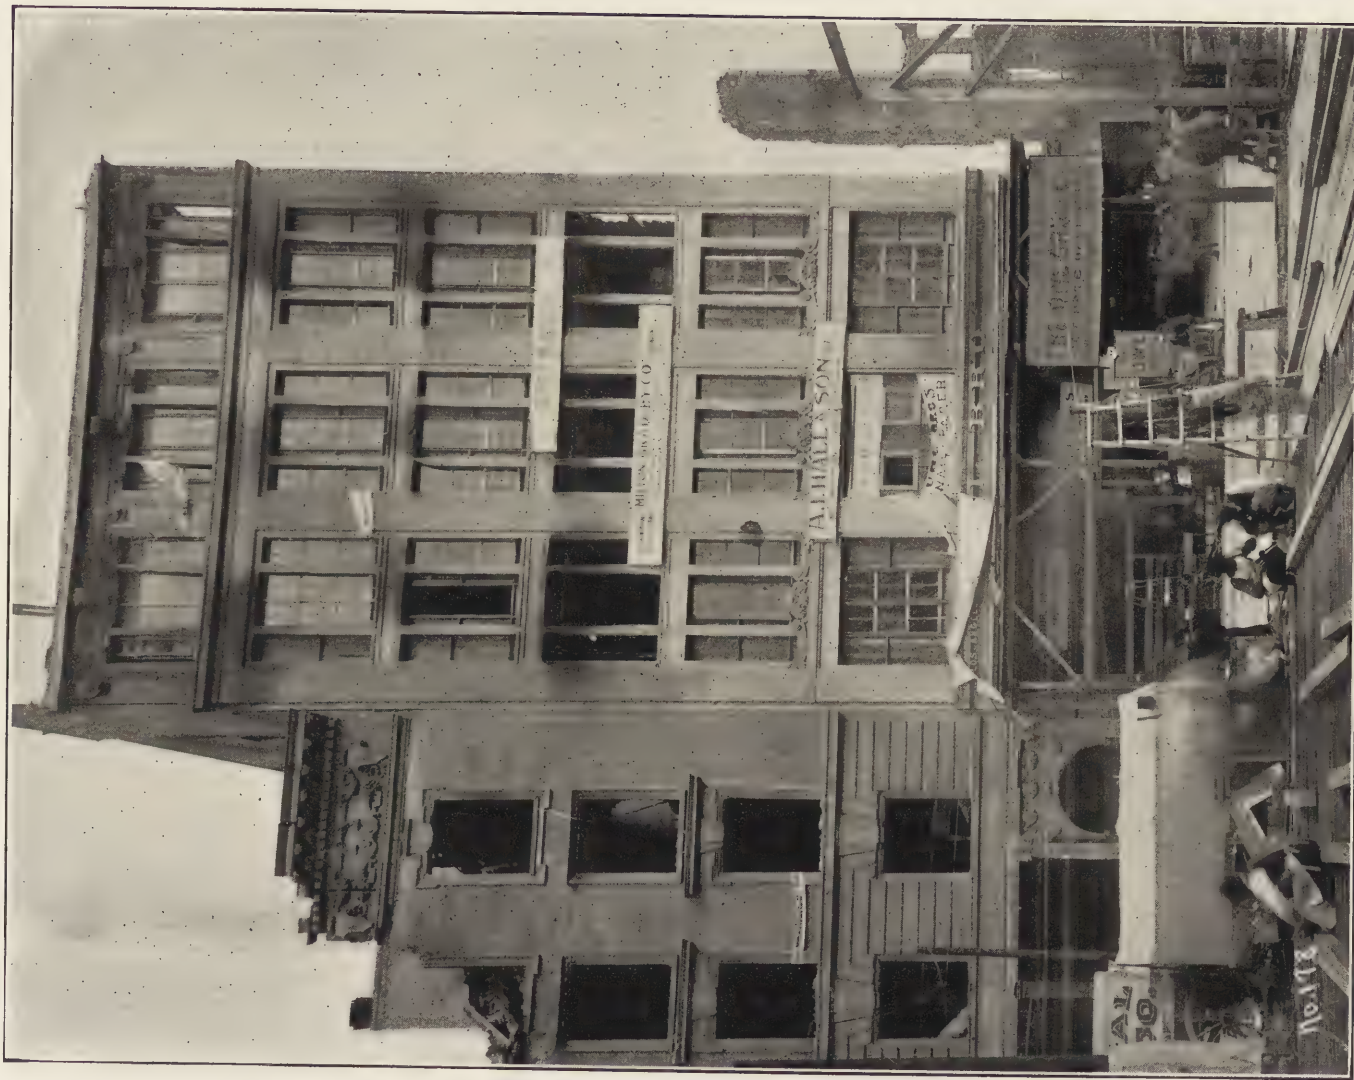
KAMM BUILDING. South Side of Market Street, near Third. The façade consists of Colusa sand-stone, which remains in first-class condition. The metal cornice has fallen away. The rear half of this building was wrecked by the failure of columns in the basement story, where a large stock of highly inflammable wall paper furnished fuel for a fire that burned continuously for a whole month. In the front portion of the building, where normal conditions prevailed, the steel skeleton frame and the Roebing concrete floors and wire lath and plaster partitions remain standing, but are deflected out of plumb in some places. The illustration shows also one-half of the front of the Spreckels Building Annex on the left-hand side.

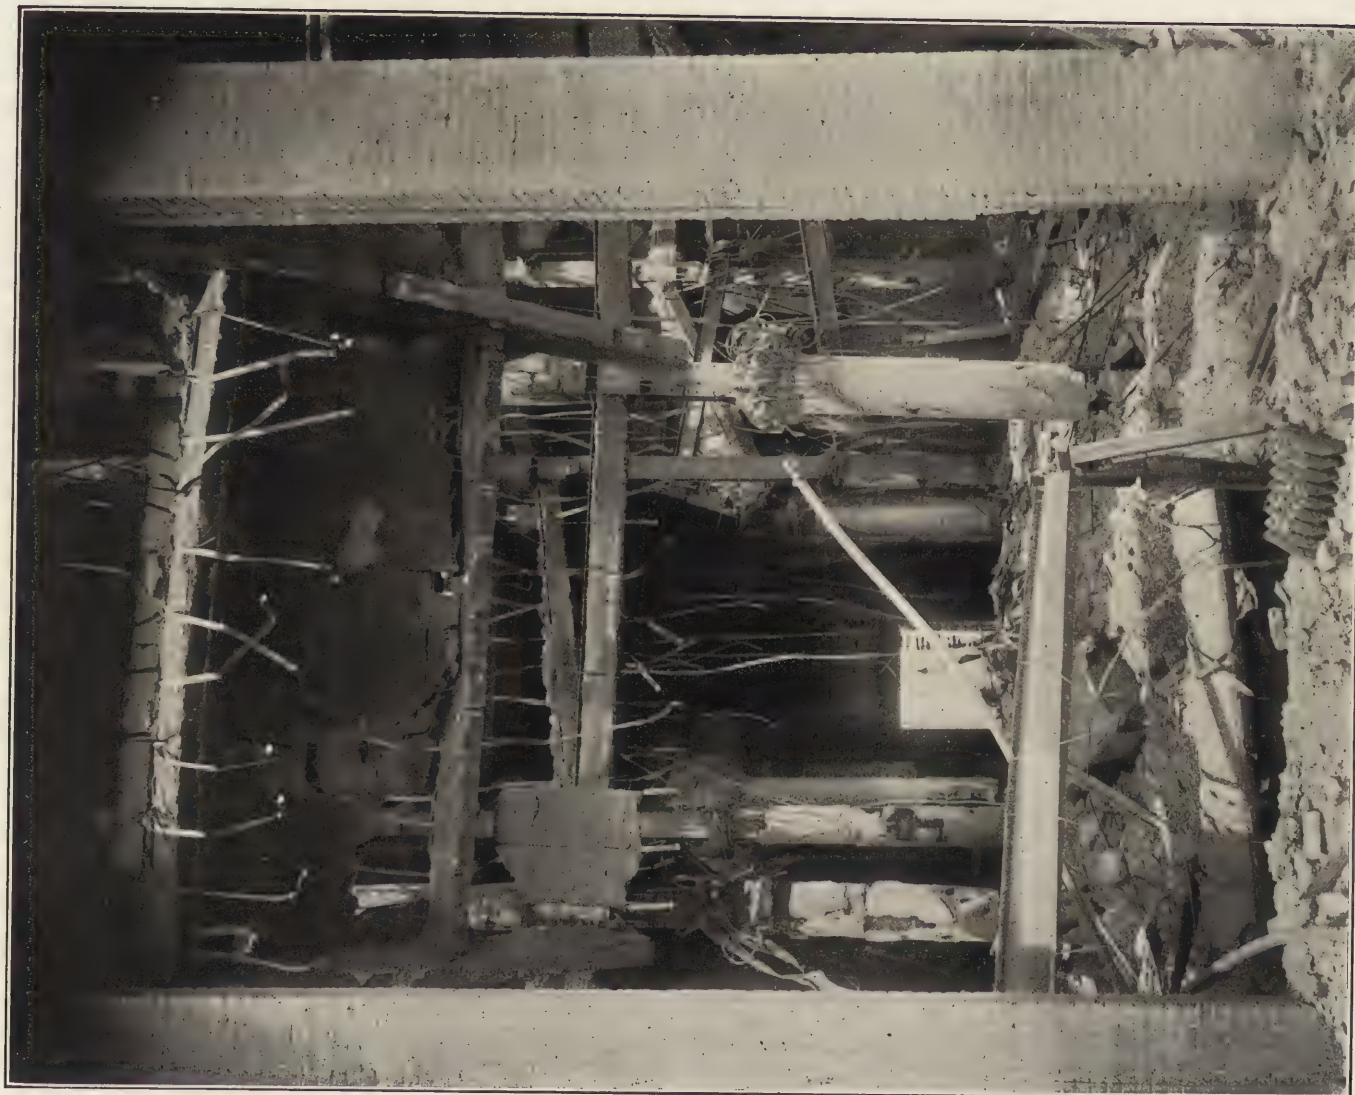
KAMM BUILDING. Looking into the wrecked rear portion from Stevenson Street. The basement of this building was used as a store-room for a wall-paper concern, and was filled solidly with stock. The heat from the burning of the wall-paper stock buckled the columns to the extent of 6 or 8 ft. of their length and wrecked the entire rear portion of the building. The fire in the basement was still burning on May 19th, when this building was inspected, a month after the origin of the conflagration. Note the concrete floor slabs, though cracked and badly injured, still clinging to the steel beams. The soffit protection of the beams is wonderfully tenacious.

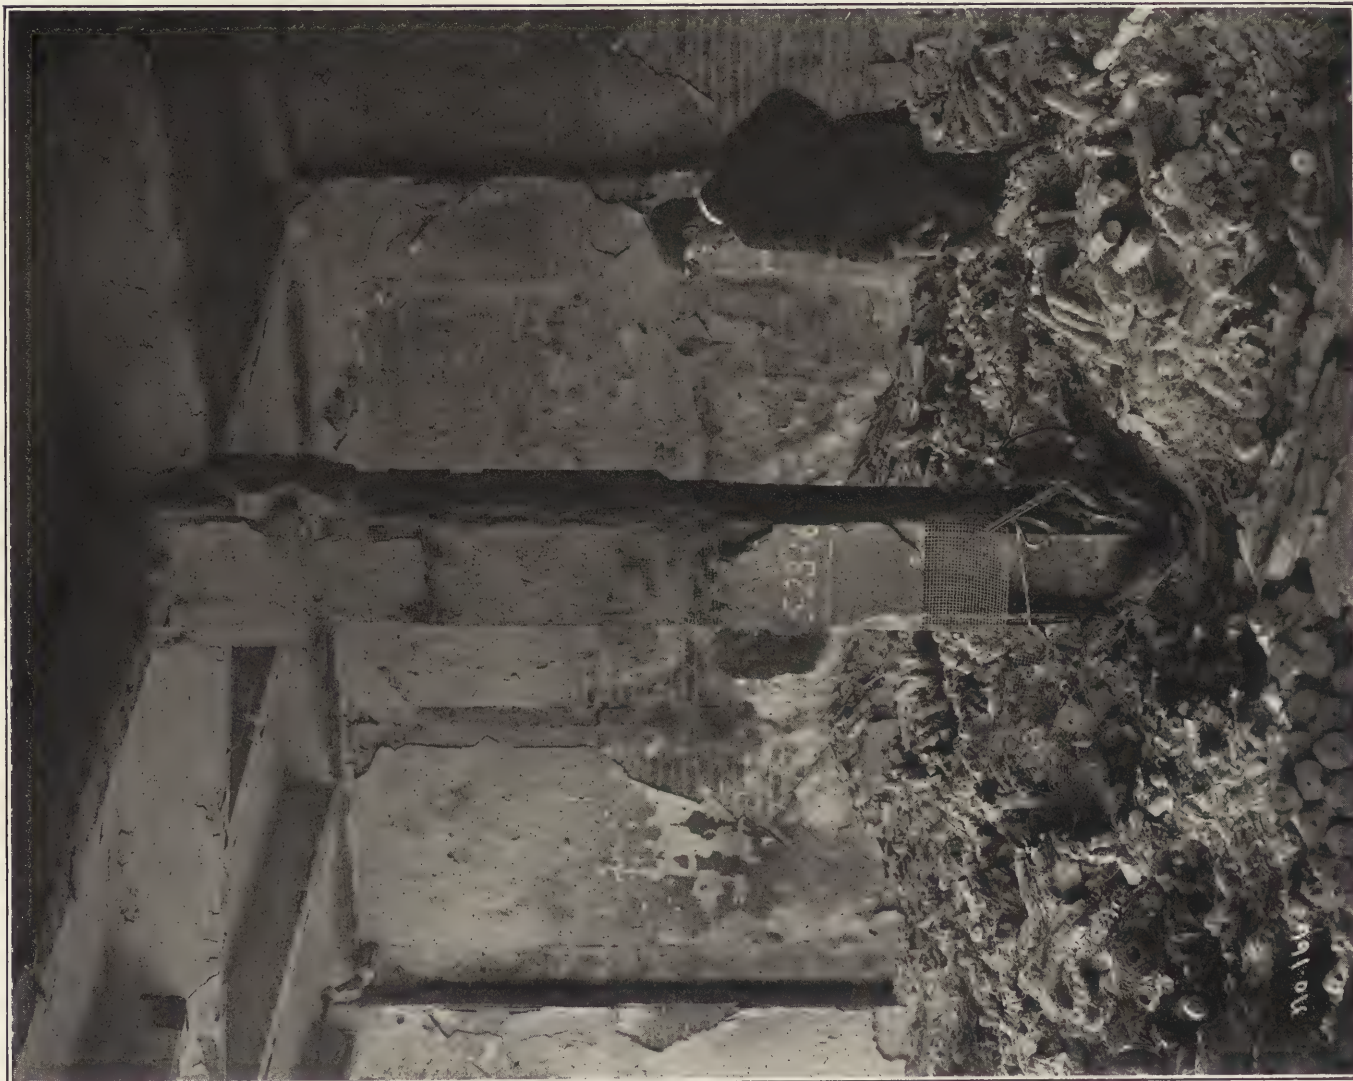
KAMM BUILDING. Second Story. Showing a buckled column near the floor level. The portion of the building shown in the photograph was occupied by a wall paper concern, and contained large quantities of stock. The paper was consumed, leaving ashes in the form of the original rolls. The man in the photograph is standing knee deep in white ashes, which are 4 feet deep at the wall in the rear. Note the condition of the Roebing concrete floors and beam soffit protection overhead. These were subjected to a hot and long-continued fire, without materially affecting the concrete floors or destroying the crimped wire lath and cement plaster soffit protection of the beams and girders. The settling of the floors, caused by the buckling of the column, caused cracks along the haunches of the beams, which in this form of construction did not weaken the floor slab.

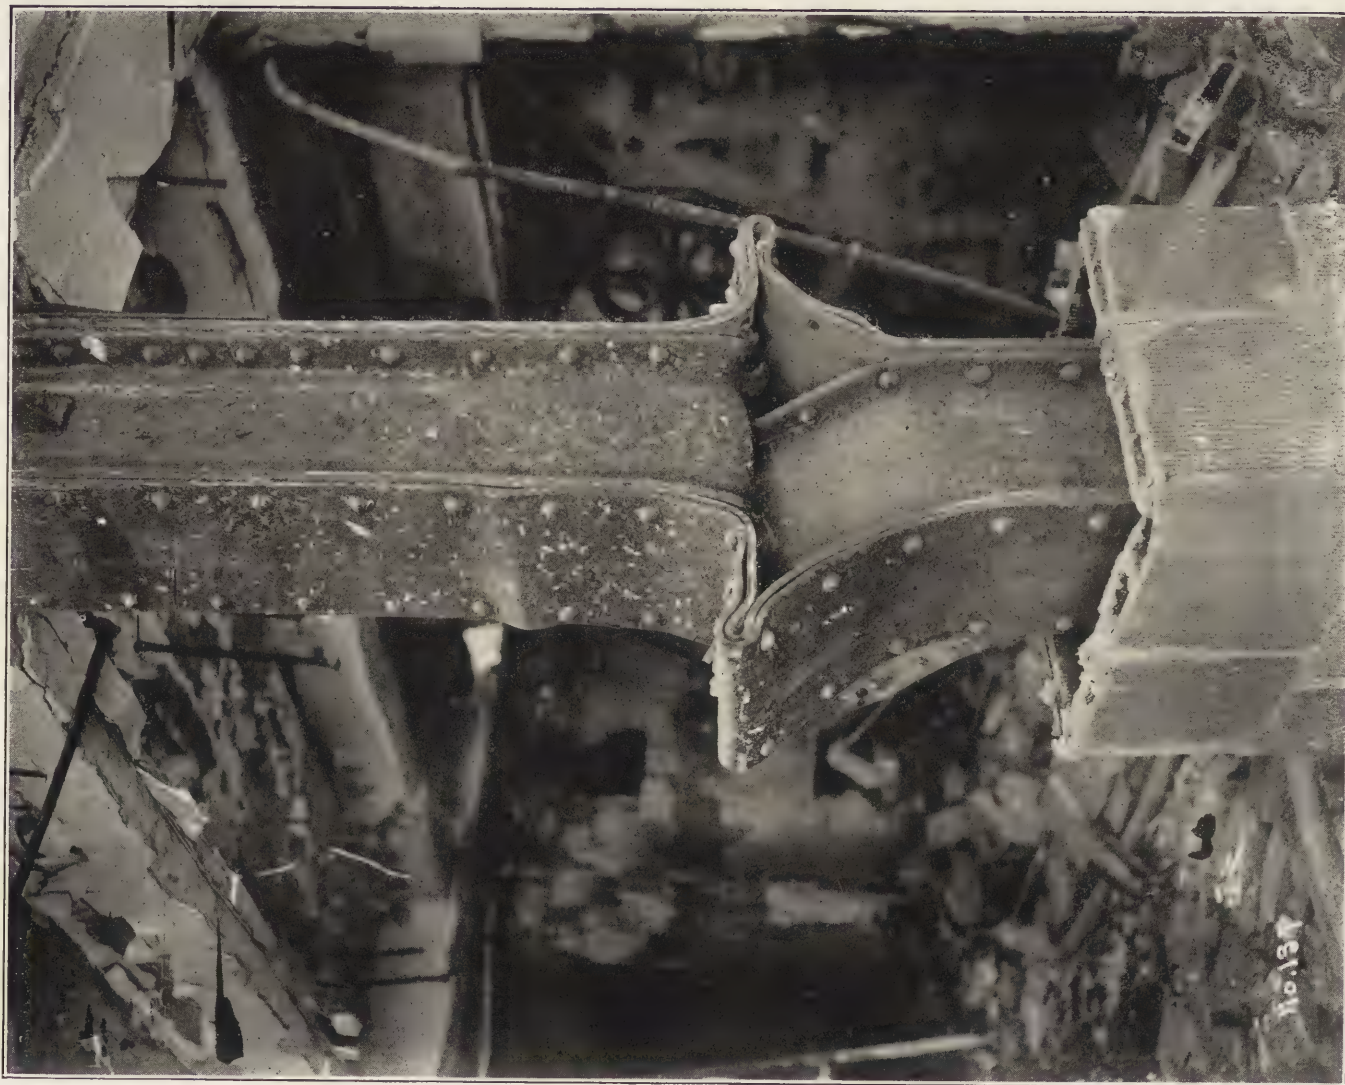
ARONSON BUILDING. Basement Story. The failure of the hollow tile column protection caused the column to buckle, letting down the floors above about two feet. The Roebing concrete floors are in good condition. Note the soffit protection clinging to the girder in the upper right-hand corner.

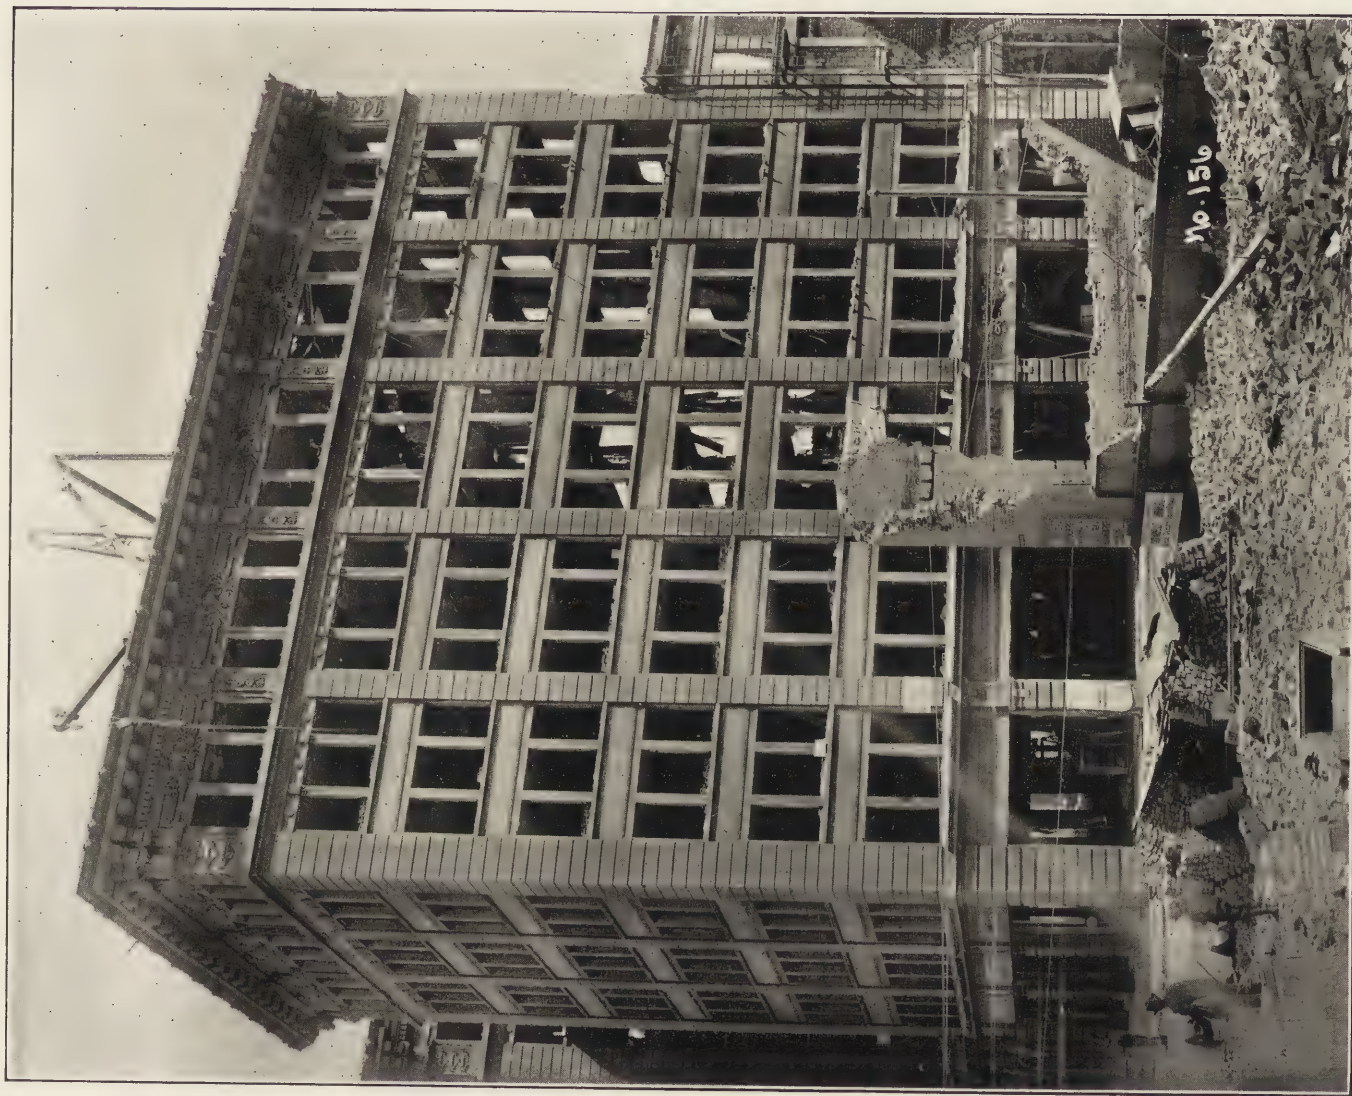
RIALTO BUILDING. Southwest Corner New Montgomery and Mission Streets. Showing the Mission Street wing (about one-half of the building). The exterior is only slightly damaged. Note the characteristic earthquake damage to the piers at the fifth and sixth story levels at the right. A small section of the interior of this wing of the building was wrecked, as is shown, and a much larger section in the other wing of the building was similarly wrecked. Both failures were caused by insufficient column protection in the basement. The concrete floors and the metal lath ceilings and column protection are in good condition. The hollow tile partitions are badly damaged and wrecked in many places.

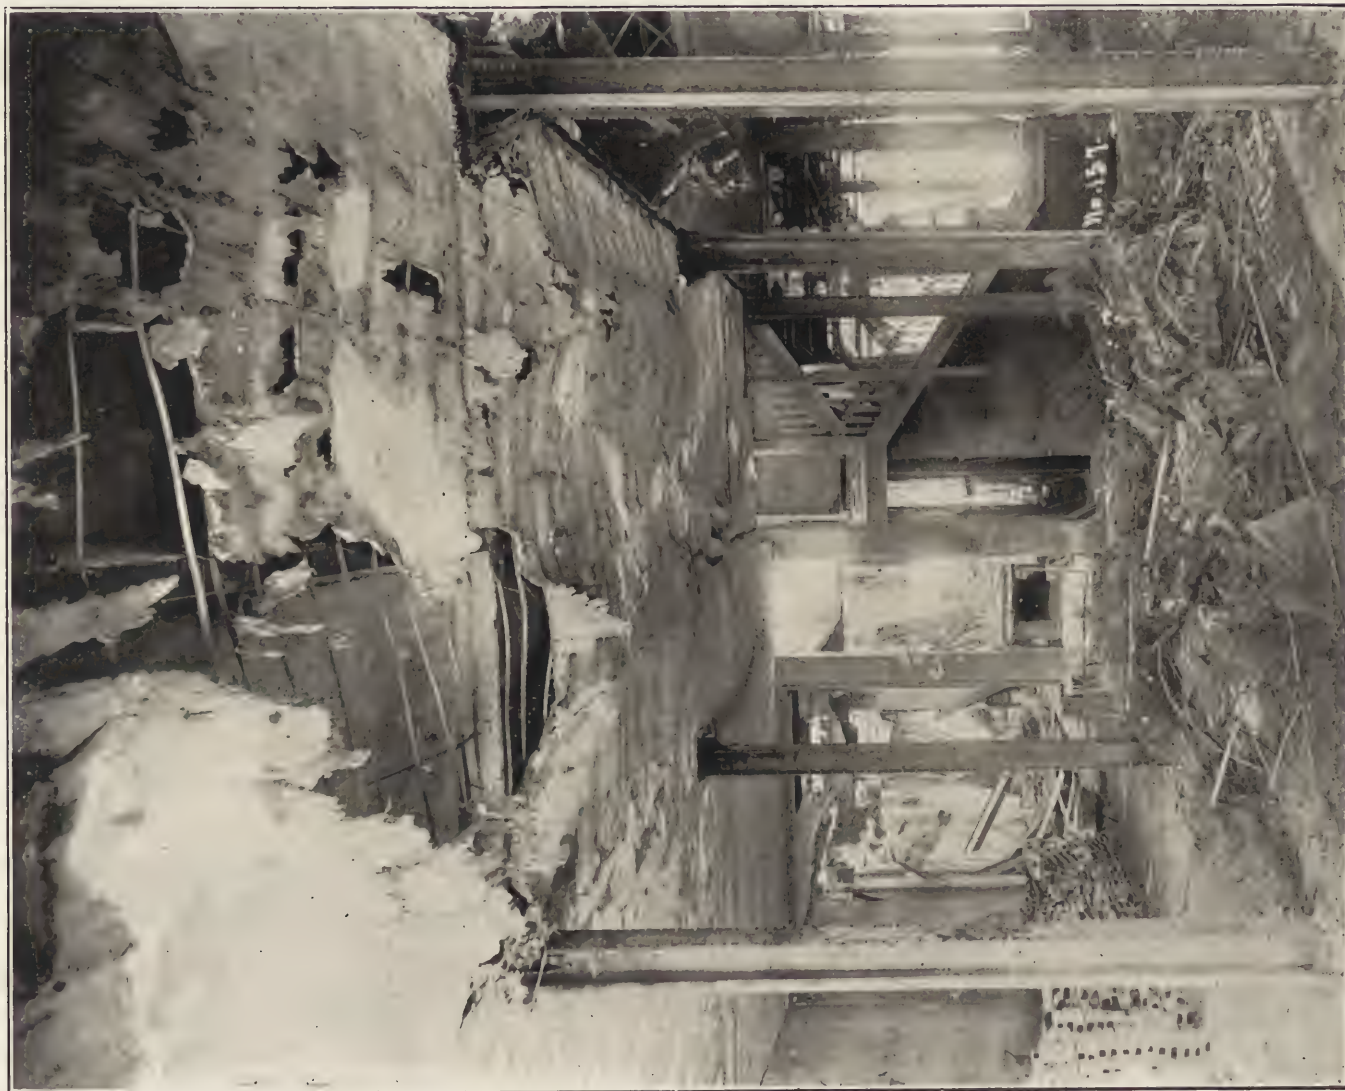
RIALTO BUILDING. First Story. Showing the failure of the light-gauge, expanded metal lath and plaster ceiling. A fire of considerable intensity occurred in this story, causing the failure generally of the hollow tile partitions as well as the ceiling. Note that the wire ties, which originally held the expanded metal in place, remain on the furring bars, showing that the light-gauge, expanded metal was incinerated and broke away from the wire supports. The photograph was taken after the metal lath and plaster column protection had been completely removed from the columns and the partition blocks had been piled on the left, as shown.

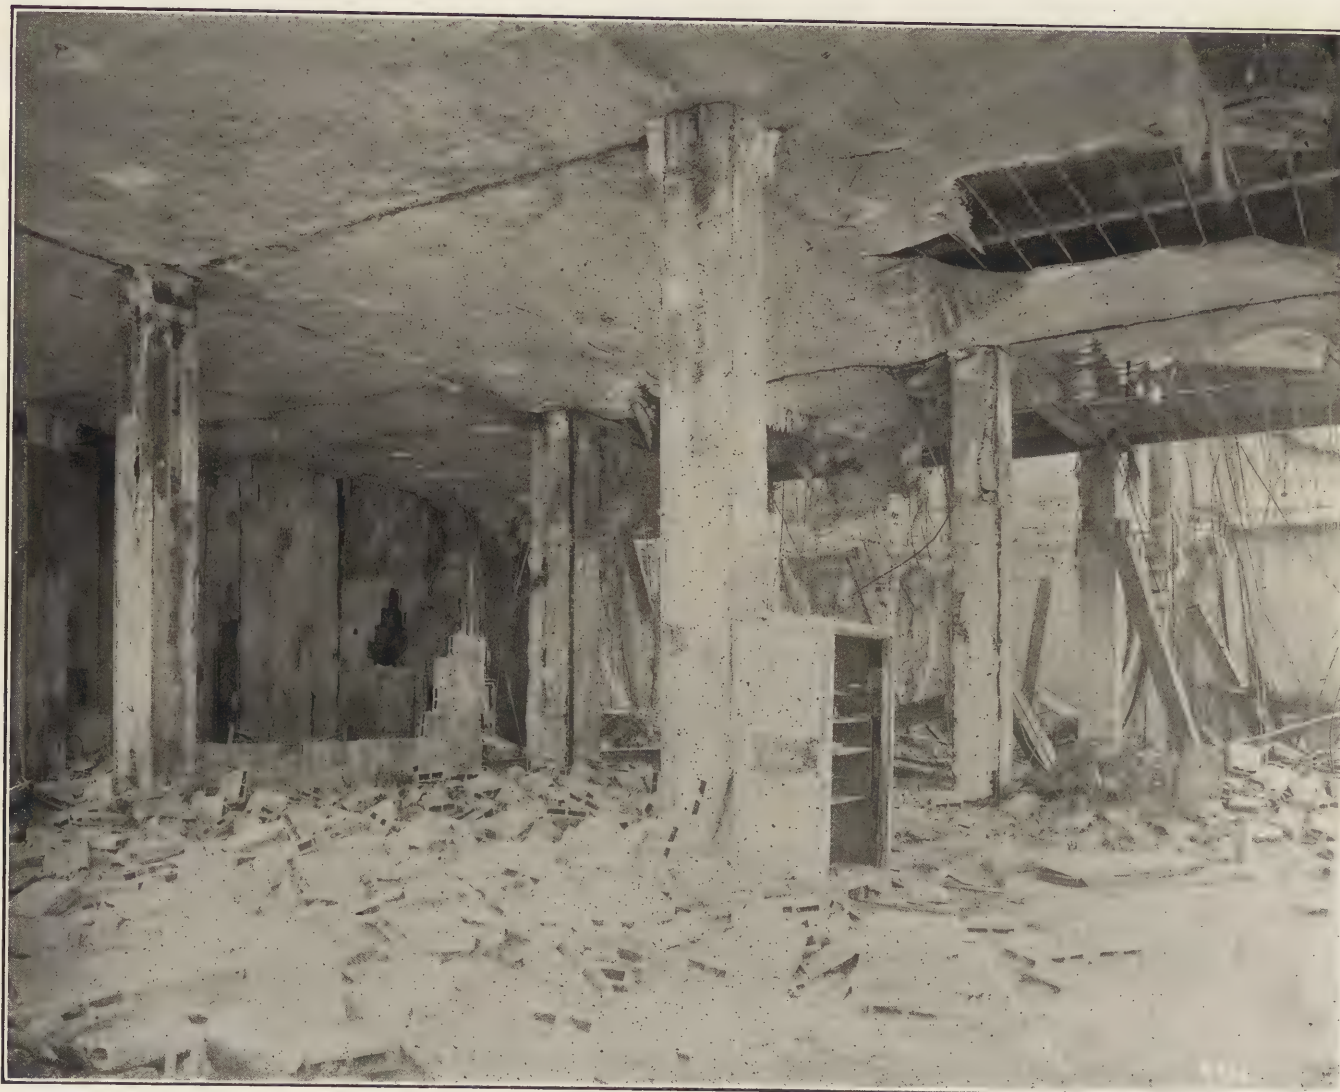
RIALTO BUILDING. First Story. Looking toward one of the collapsed sections of the building. Showing the typical condition of the double expanded metal lath and plaster column protection and the 3" hollow tile partitions. The fire-proof floors are of stone concrete with $\frac{1}{2}$ " sq. Johnson steel bars at 16" centres and No. 16, 3" mesh expanded metal imbedded in it. The flat ceiling of expanded metal lath and plaster has failed in numerous places.

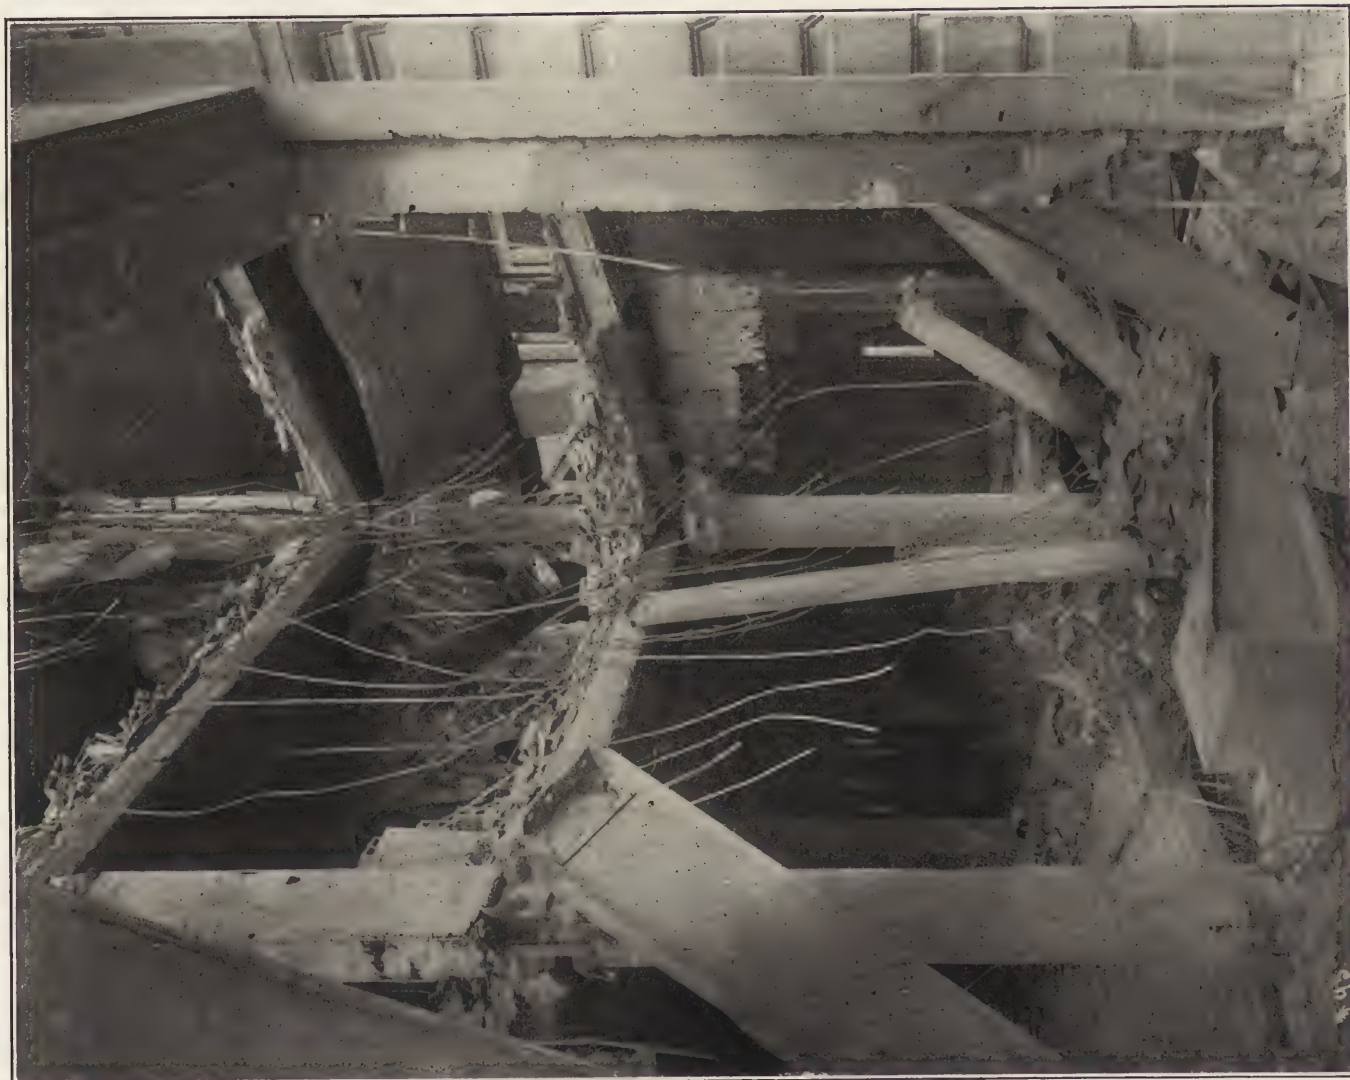
RIALTO BUILDING, First Story. Looking from the building line near the New Montgomery Street entrance. Showing a collapsed section caused by the buckling of a column in the basement story.
